**Flood Control Project Maintenance
Levee Inspections****LMA District Cover Sheet****Spring 2015 Levee Inspection Results****Reclamation District No. 2075 McMullin**

Spring 2015 Levee Inspection Results

Reclamation District No. 2075 McMullin

Waterway			Bank	Unit Miles
Unit No. 01 San Joaquin River			Right	7.45
	Spring (March - May)	Summer (June - August)	(September - November) Fall	Winter (December - February)
Unit Maintenance Rating (Fall Only)				
Date of Inspection	04/07/2015 - 04/07/2015			
DWR Inspector	Herman Phillips			
Accompanied By	Eddie Cordoza

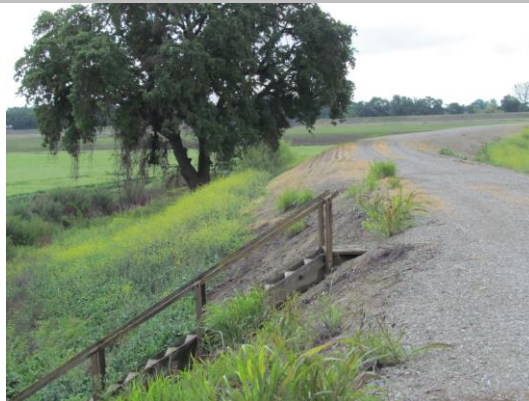
Photo 1 of 1 : SP_2015_RD2075_315_14_20150604_00008.jpg

LM Start	0.11	Rating **	M	Issue No.	14
LM End	0.26	Issue Type +	Ma	Location *	LS
Category	Earthen Levee			GPS Latitude/Longitude	
				Start	End
Item	Vegetation			37.748365 °	37.746170 °
				-121.289758 °	-121.289578 °
DWR ID	DWR_RD2075_01_s_2015_14				
Action/Comments					
Remove the wild growth other than native grasses from the levee slopes.

RD 2075 looking downstream at the landside levee slope.

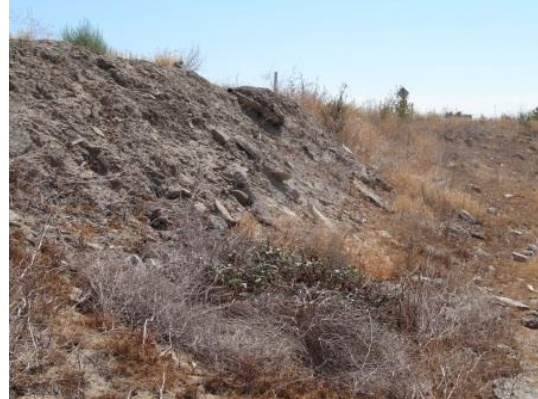
Photo 1 of 1 : SP_2015_RD2075_315_12_20150312_00001.jpg

LM Start	5.28	Rating **	M	Issue No.	12
LM End	5.28	Issue Type +	Ma	Location *	WS
Category	Supplemental			GPS Latitude/Longitude	
				Start	End
Item	DWR Erosion Survey			37.727933 °	37.727933 °
				-121.274491 °	-121.274491 °
DWR ID	DWR_RD2075_01_s _ 2015_12				
Action/Comments					
Inspector Comments: 09/10/2013: No significant change observed. 09/13/2012: No significant change observed. 08/18/2011: No significant change observed. Some new material added to the water side levee slope, but the added material is loose and seems not helping the levee protection. 10/05/2010: No significant change observed. Levee slope has minimal vegetation and lacks rip rap protection. Sandy material found on the lower and middle slope is an undesirable material to have on a levee. 08/05/2010: Recommended for annual assessment and monitoring during flood events, per CLRO. 08/20/2009: No major change since last visit; site is located in an oxbow; slope surface consists of very sandy material; there is a tree on site leaning and with exposed tree roots; site is recommended as a local maintenance issue, per CLRO CES Evaluation 2008 Report; Eddy Cordoza from the district is aware of the site and is looking for recommendation; site is previously rated "U". 08/17/2007: Site is close to an irrigation pump inlet. [2014 Site ID:RD2075U01RM64.34]

Looking downstream of the erosion site.
